# Kaka

## PWSID No. 0400037

Sanitary Survey  
March 22, 2016

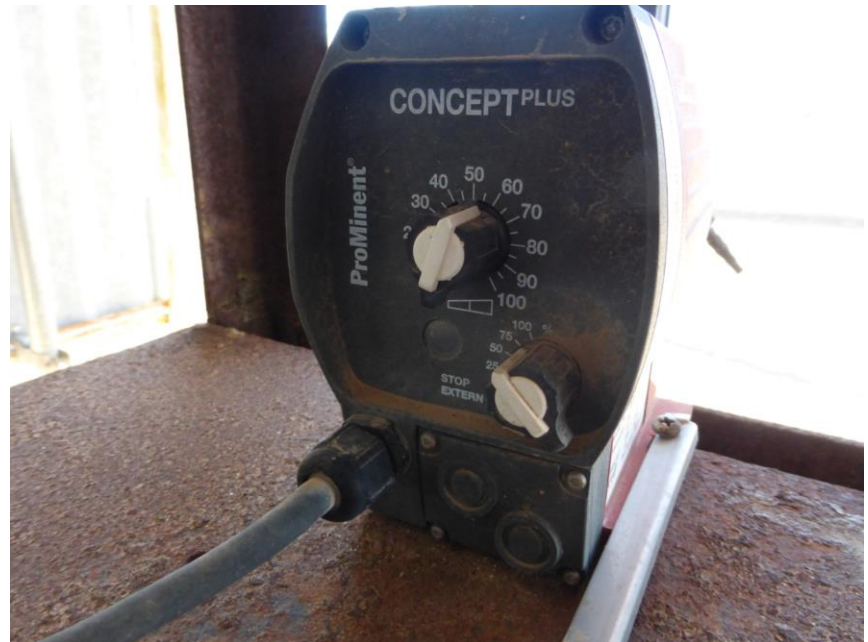
Treatment for Well 1 consists of chlorination with sodium hypochlorite. The NSF-certified sodium hypochlorite is diluted and injected in the well's discharge piping with a ProMinent ConceptPlus positive displacement pump with a capacity of 0.26 gph.

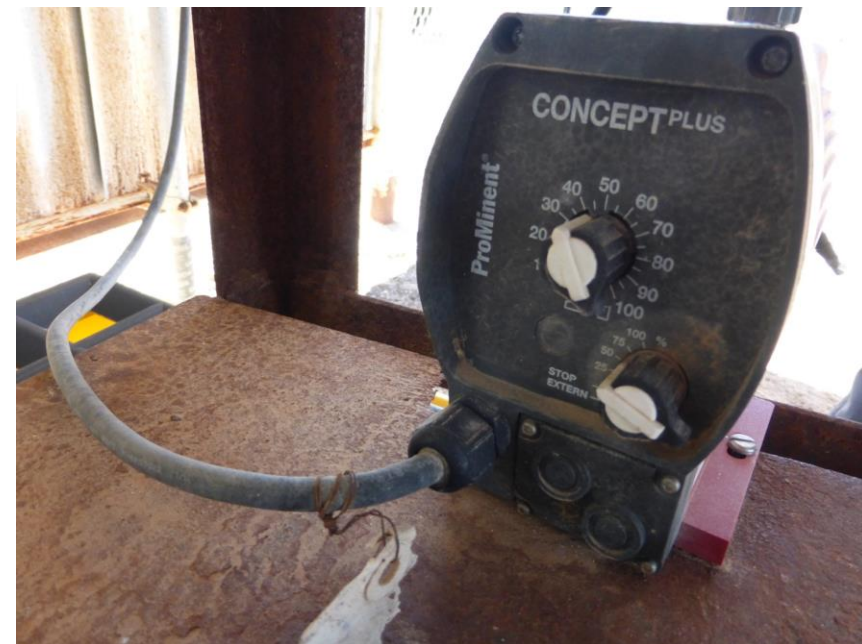
Treatment for Well 2 consists of chlorination with sodium hypochlorite. The NSF-certified sodium hypochlorite is diluted and injected in the well's discharge piping with a ProMinent ConceptPlus positive displacement pump with a capacity of 1.03 gph.

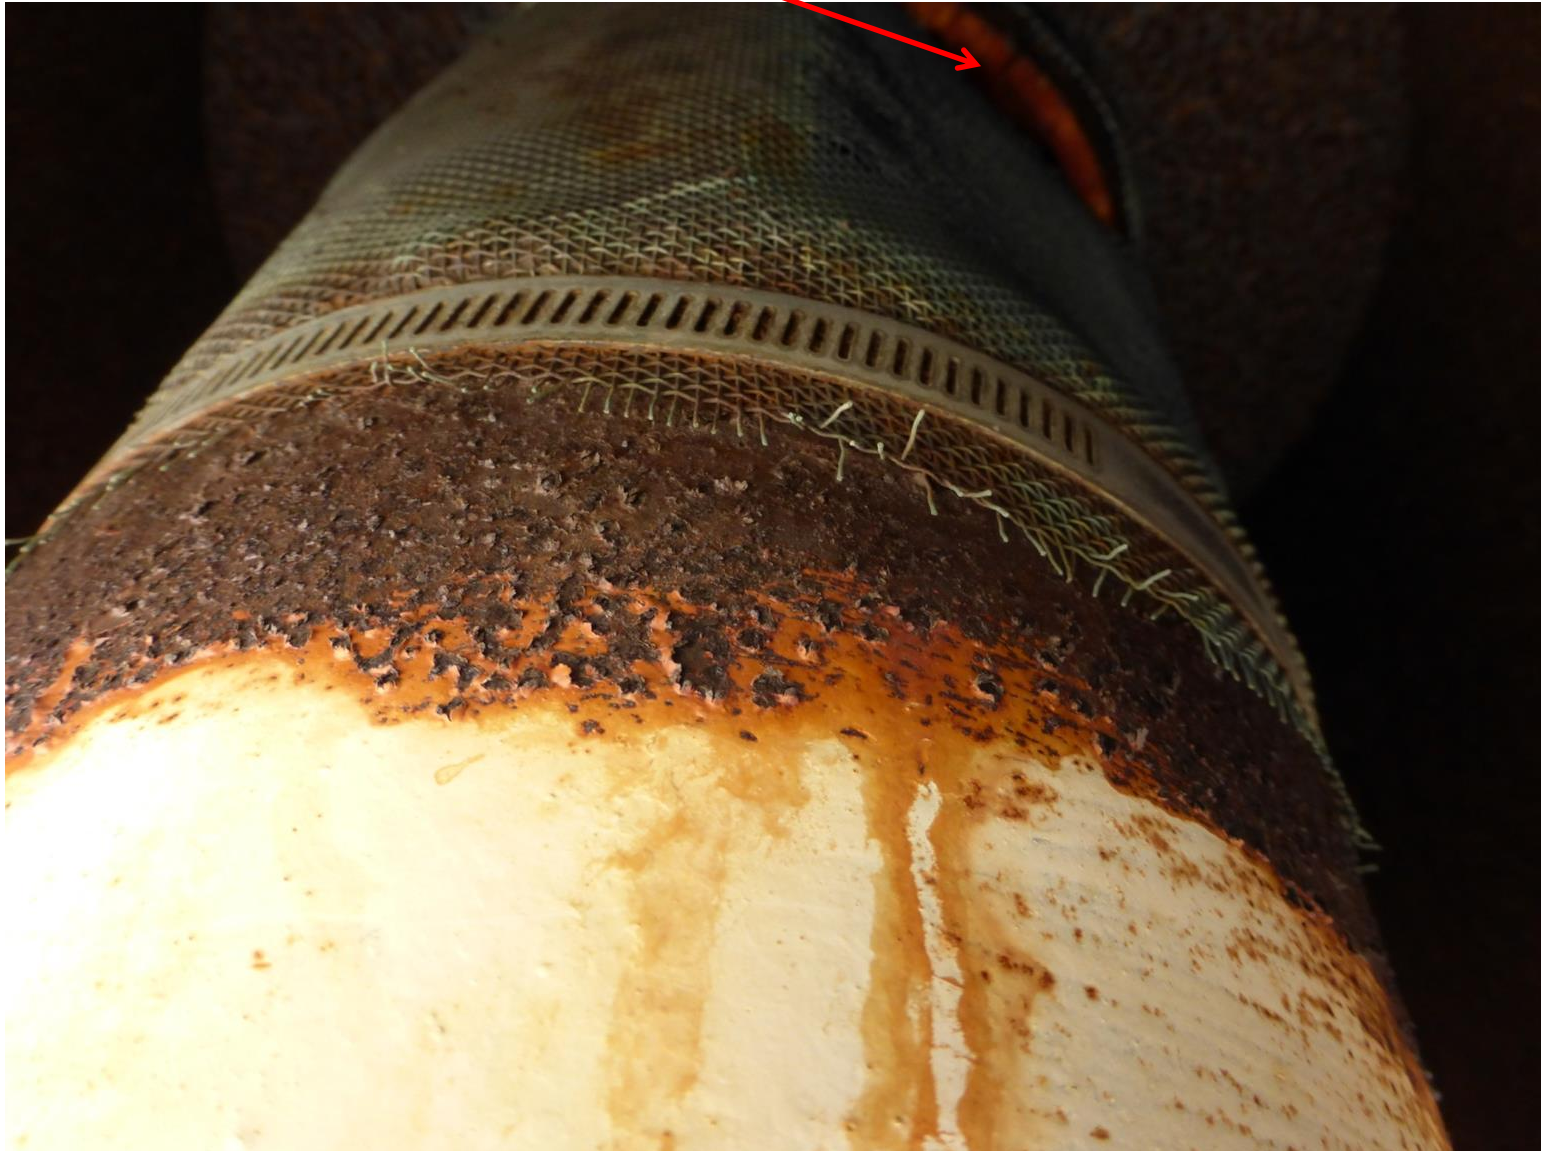
Storage Tank 1 (ST001)

The vent screen appears torn at the top.

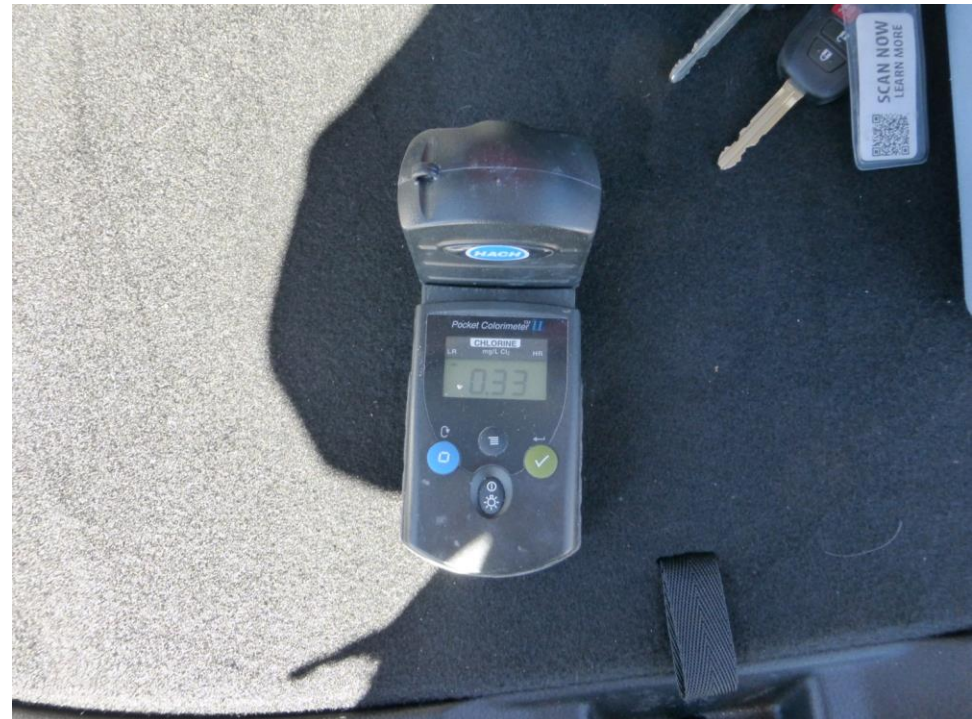
**A pressure reading taken at a home in the community showed a pressure of approximately 30 pounds per square inch (psi).**

**A chlorine residual taken at the same location showed 0.33 mg/L.**
